Re: Albion-Sheraton Township Landfill, Albion, Michigan
TDD# 5-8910-04

**ALBION-SHERIDAN TOWNSHIP LANDFILL
REMOVAL ACTION PLAN
ALBION, MICHIGAN**

January 1990

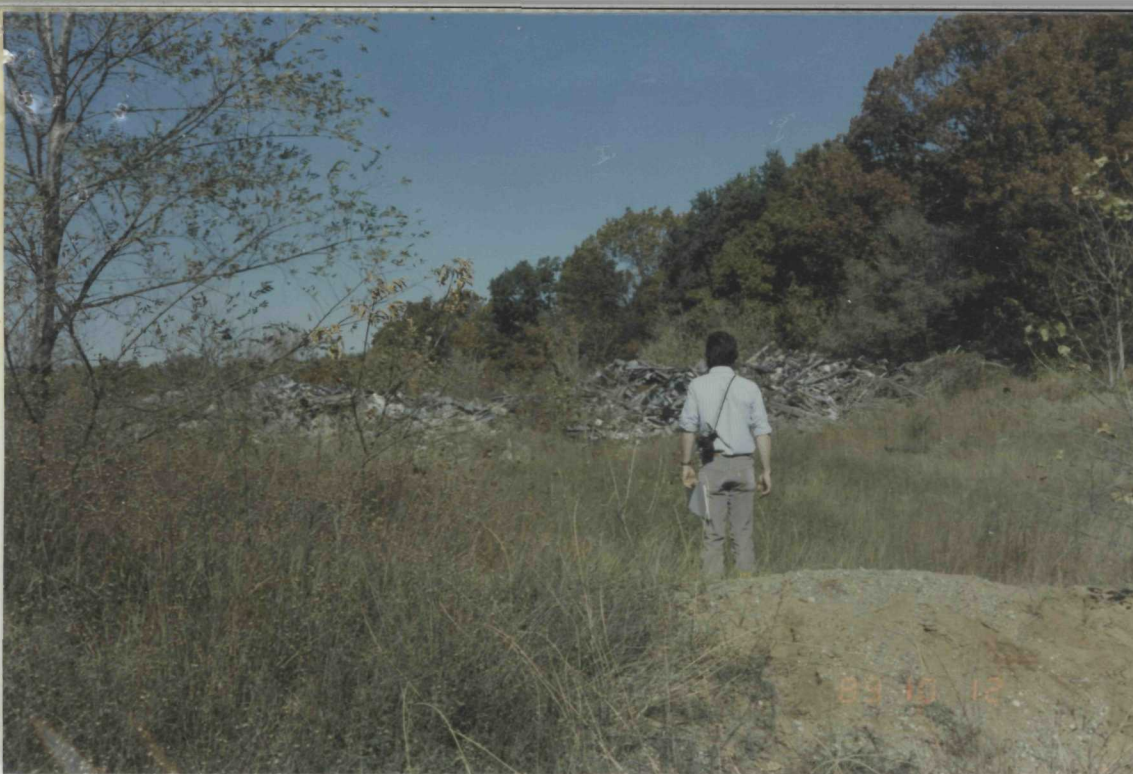
ROLL 1 PHOTO 0
 Albion-Sheridan Township Landfill
 Albion, Michigan
 View of demolition debris along the northeast
 perimeter of landfill. Area being viewed by field
 investigator from Center for Environmental Health
 Sciences - Michigan Department of Public Health.
 Photo by J. Boeckman JS October 12, 1989

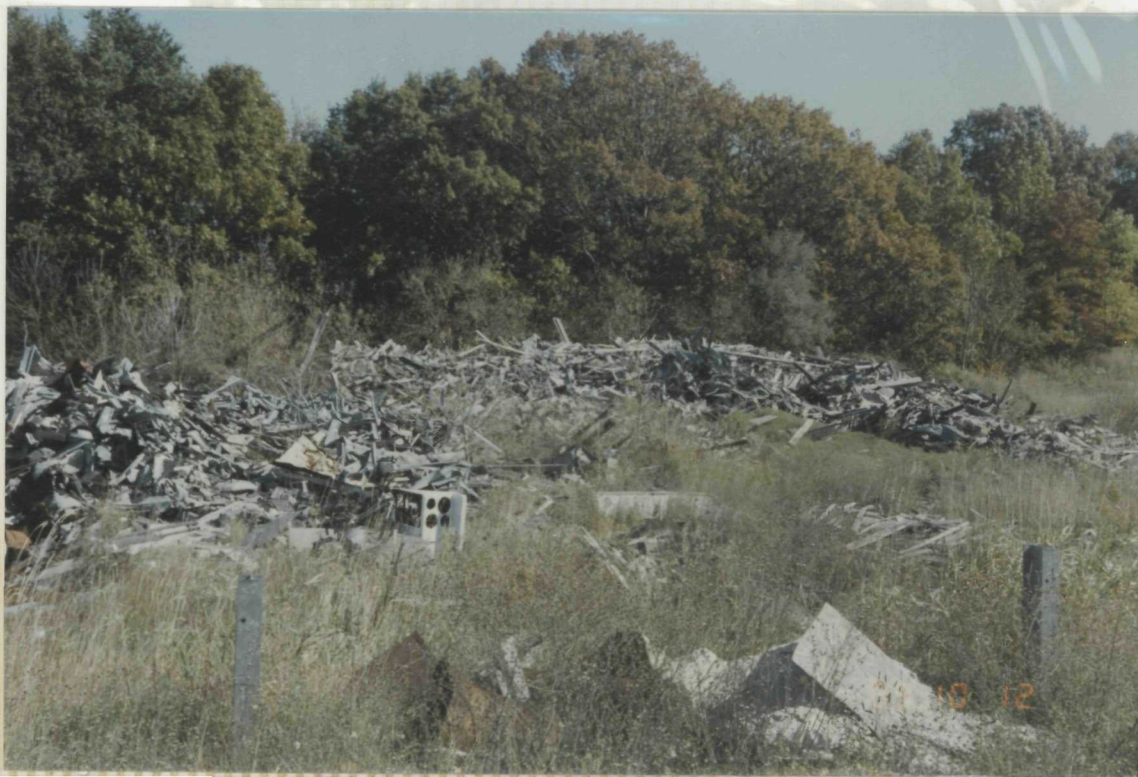
ROLL 1 PHOTO 1
 Albion-Sheridan Township Landfill
 Albion, Michigan
 View of demolition debris along northeast edge
 of of landfill. Majority of debris consisted
 of discarded appliances and building rubble.
 Photo by J. Boeckman JS October 12, 1989

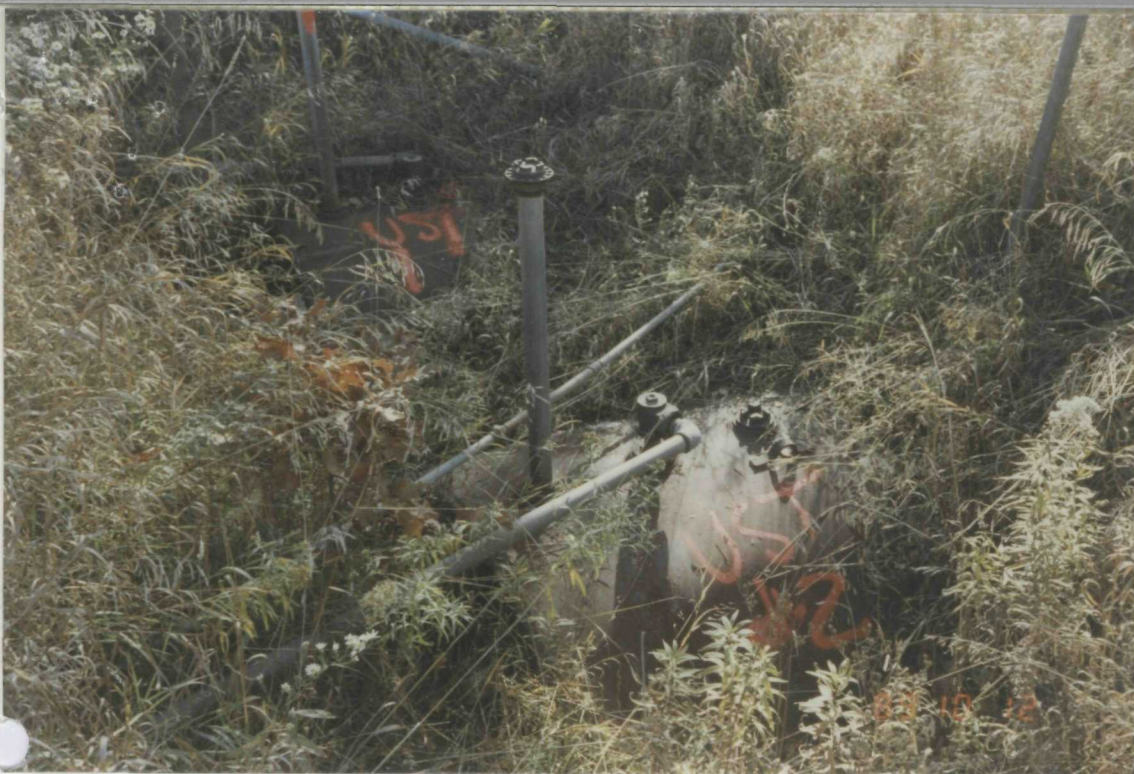
ROLL 1 PHOTO 4

View of two partially buried gasoline storage tanks. Tank capacity was approximately 500 gallons each. Tank #1 was empty; all openings to tank #2 were either locked or rusted shut and prevented further investigation.

Two of the storage tanks observed were partially buried and connected to inoperable gasoline pumps; the storage capacity of each tank was estimated to be approximately 500 gallons. The first tank was empty, and because the second tank was locked, the type and quantity of any contents could not be determined. The third storage tank, which was positioned horizontally on the landfill surface, was empty, and its storage capacity was estimated to be 8,000 gallons. The exterior surface of most of the twenty-seven 55-gallon drums were rusted; eleven were empty and sixteen were full or partially full of material. Four of the five small metal containers held some amount of material; two contained unused industrial grease. Concurrent with the container inventory, the TAT conducted air monitoring with an HNu photoionization detector (HNu) equipped with an 11.7 eV probe. Only two readings were observed above the background level: inside drum B-4 (25 units) and at the opening of one of the two partially buried tanks (17 units).

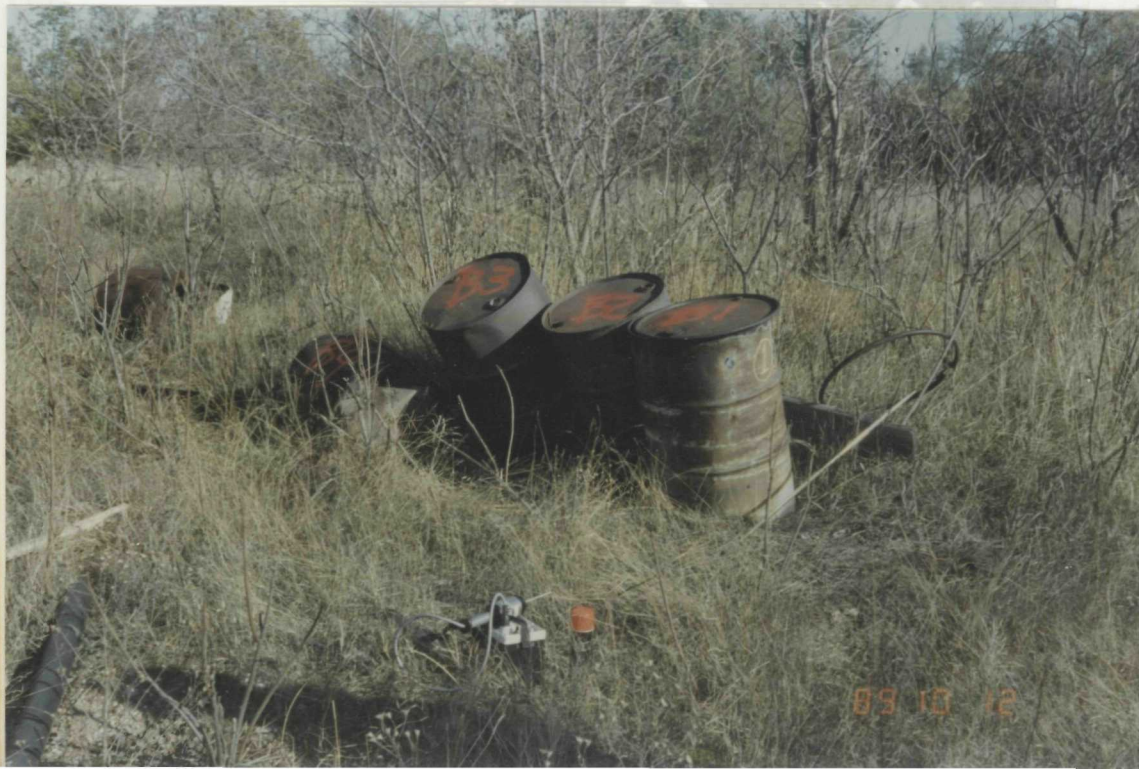
View of abandoned 55-gallon drums near the center of the landfill. The contents of the drum labeled B4 were sampled and analyzed; the material was a RCRA F-listed waste.

During a solvent scan performed on the sample collected from drum B-4, a total of five VOCs were detected in the sample, and 23 additional VOCs were tentatively identified. The presence of these constituents identifies this material as a U.S. EPA F-listed (F001 - F005) Hazardous Waste. The results of the solvent scan analysis are presented in Table 3.

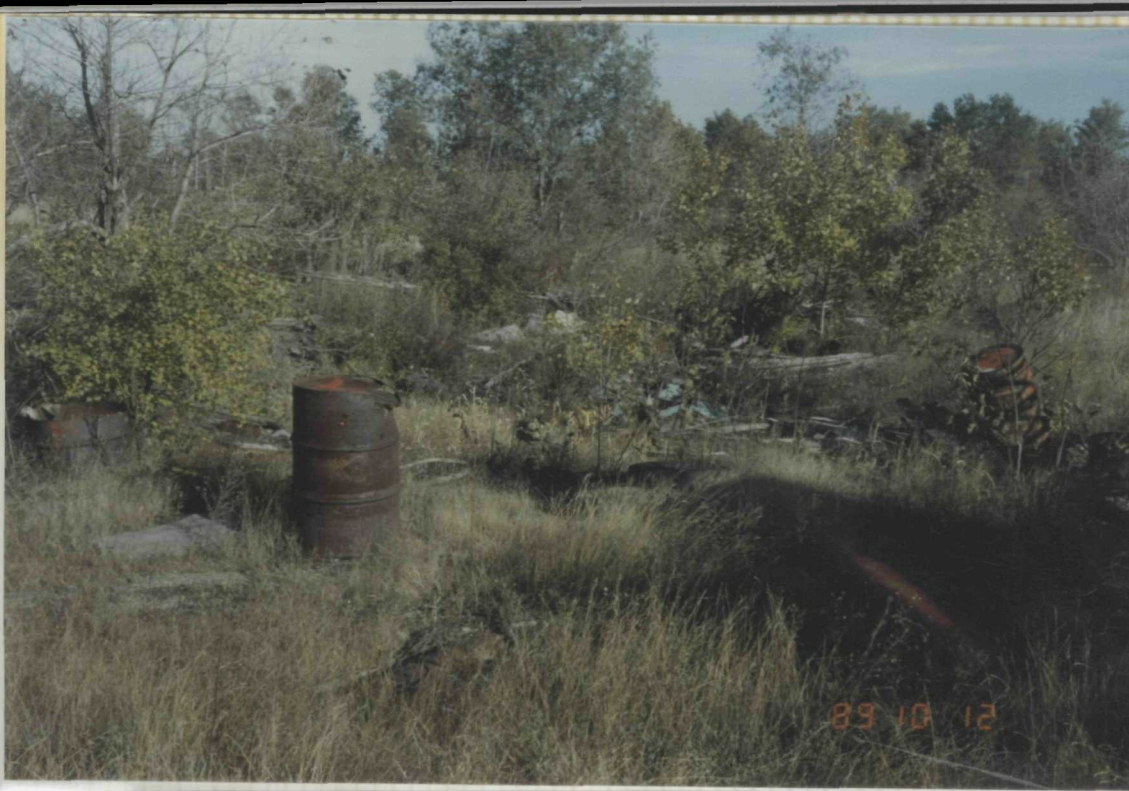
ROLL 1 PHOTO 6
 Albion-Sheridan Township Landfill
 Albion, Michigan
 View of empty, rusted drums scattered on the
 surface of the landfill. Near the drums were
 the charred remains of what appeared to be a
 small wooden structure.
 Photo by K. M. Hanlon *KMH* October 12, 1989

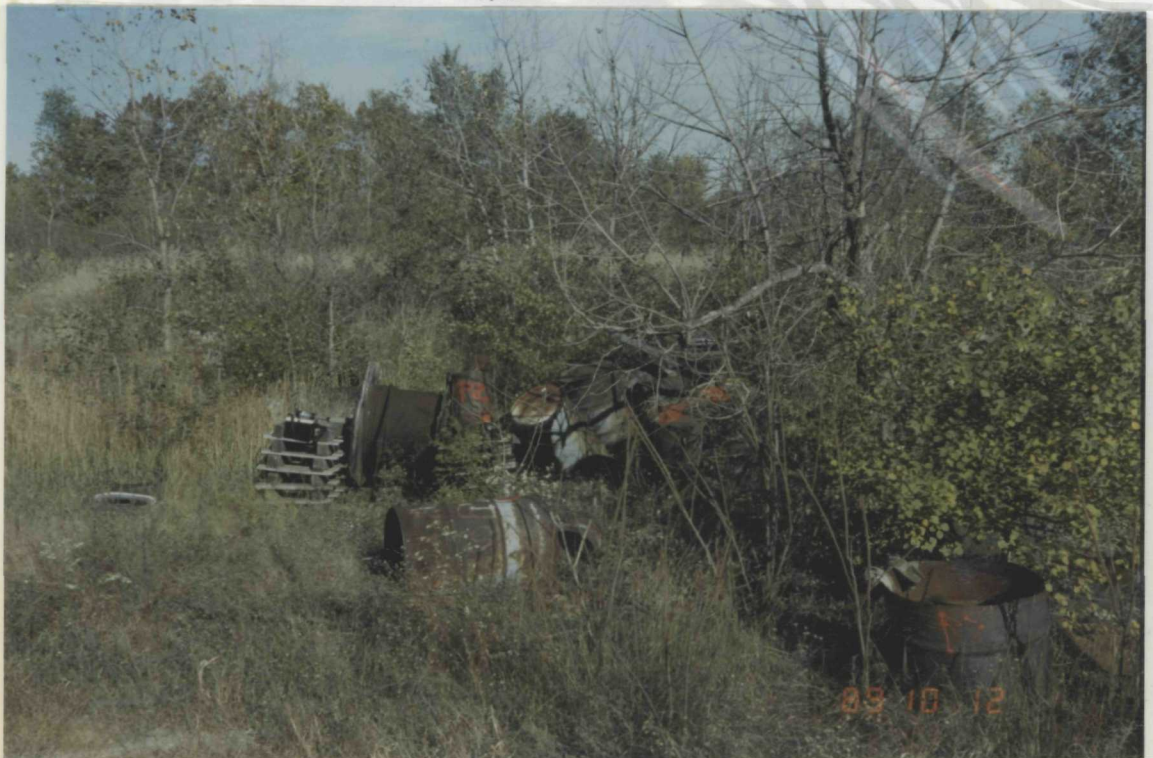
ROLL 1 PHOTO 7
 Albion-Sheridan Township Landfill
 Albion, Michigan
 View of abandoned drums at the landfill. A
 total of twenty-seven 55-gallon drums were
 found on the surface of the landfill; only
 sixteen of the total contained any material.
 Photo by K. M. Hanlon *KMH* October 12, 1989

Concurrent with the compatibility tests, the ERCS contractor would place each sampled drum and container in an 85-gallon-capacity overpack drum. This action is necessary because of the deteriorating condition of most drums and the lack of site security. Following completion of the compatibility tests, composite samples would be sent to three different disposal facilities for acceptance.

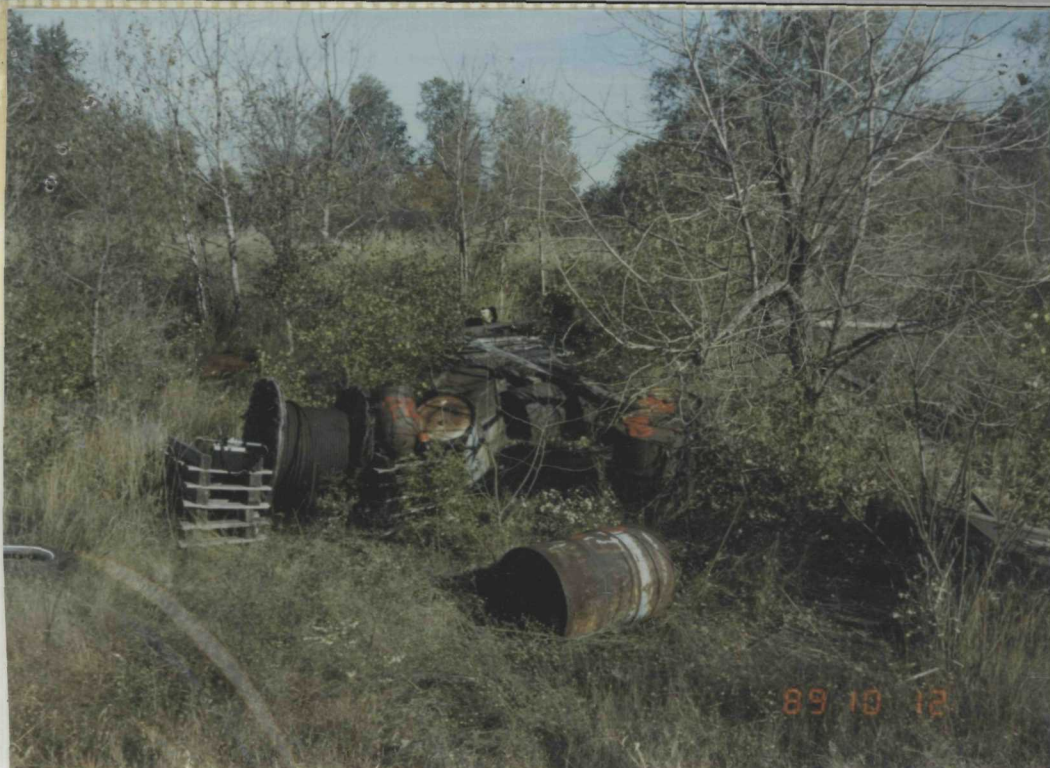
ROLL 1 PHOTO 8
 Albion-Sheridan Township Landfill
 Albion, Michigan
 View of abandoned drums at the landfill. Note
 the large above-ground storage tank in the
 photo background.
 Photo by K. M. Hanlon *KMH* October 12, 1989

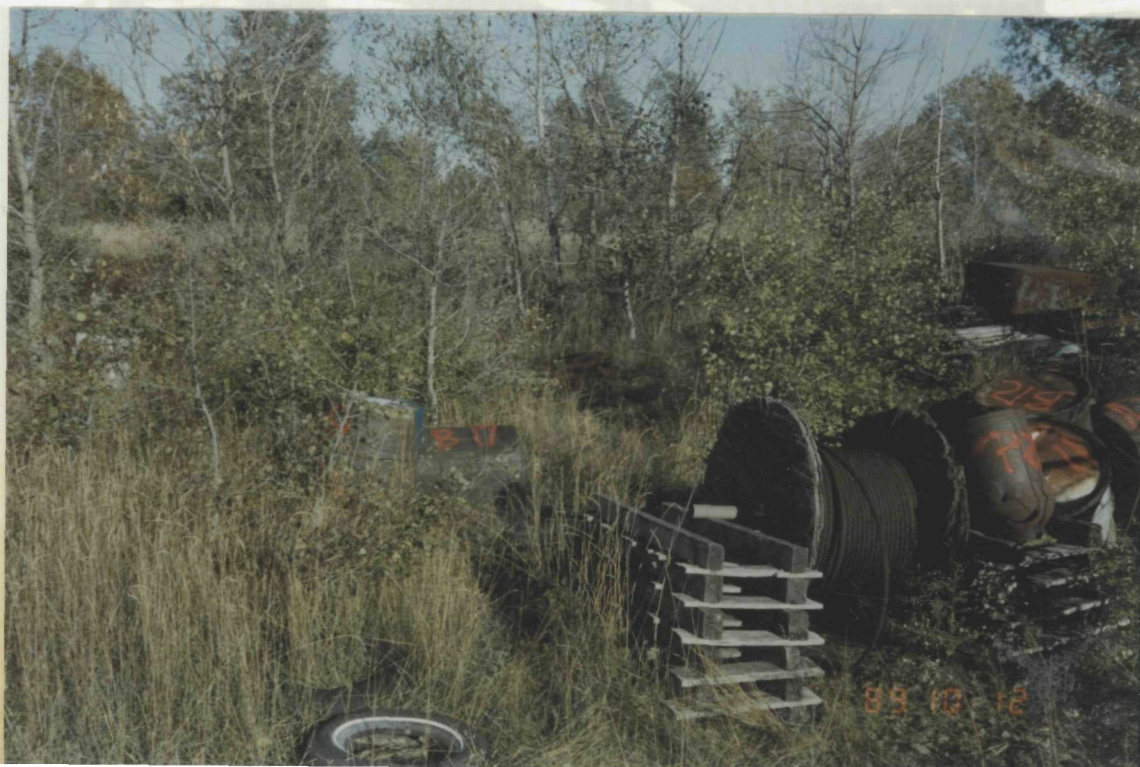
ROLL 1 PHOTO 9
 Albion-Sheridan Township Landfill
 Albion, Michigan
 View of abandoned drums and other debris found
 on the surface of the landfill.
 Photo by K. M. Hanlon *KMH* October 12, 1989

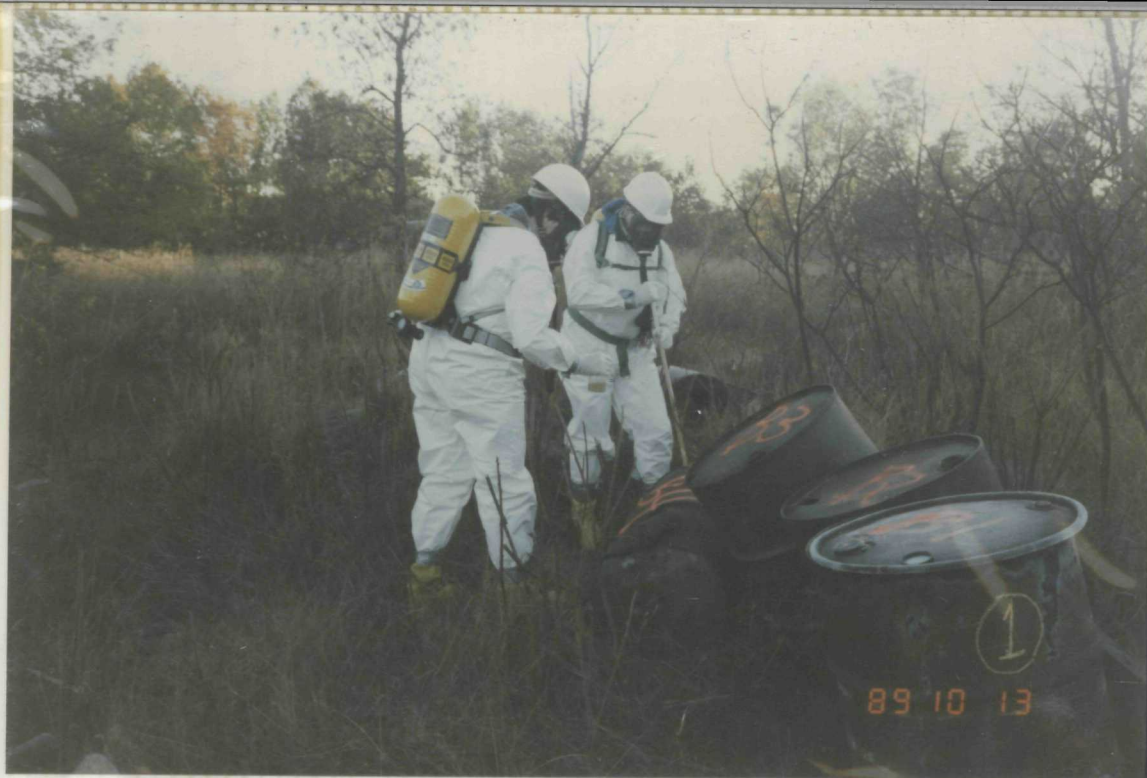
ROLL 1 PHOTO 10
 Albion-Sheridan Township Landfill
 Albion, Michigan
 TAT members Weed and Hanlon collecting a sample
 of liquid from drum B4 at the landfill. A drum
 thief was used to collect a 16 oz. sample from
 the drum.
 Photo by J. Boeckman JB October 13, 1989

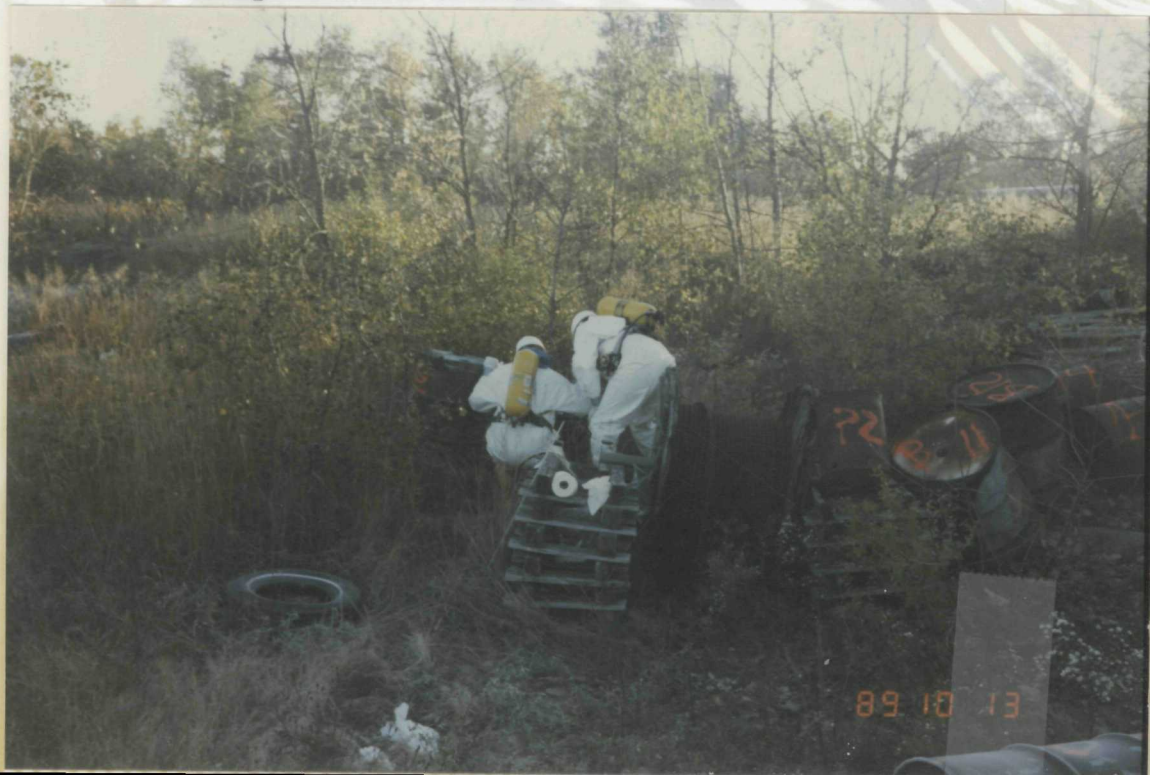
ROLL 1 PHOTO 11
 Albion-Sheridan Township Landfill
 Albion, Michigan
 TAT members Weed and Hanlon collecting samples
 from drums B16 and B17. Both drums contained
 material which exhibited the characteristic of
 ignitability.
 Photo by J. Boeckman JB October 13, 1989

The samples collected from drums B-9, B-16, and B-17 were each determined to have flash points below 140°F, thereby exhibiting the RCRA characteristic of ignitability (40 CFR Part 261.21). The

wastes in drums B-9, B-16, and B-17 are therefore classified as D001 hazardous wastes. Because the flash point of the sample collected from drum B-4 was $>140^{\circ}\text{F}$, it was not considered to exhibit the characteristic of ignitability. None of the four samples exhibited RCRA characteristics of corrosivity or reactivity. Table 2 presents the results of the sample analysis for RCRA characteristics of hazardous waste.
